CWD - PAYSON 40" TRANSMISSION MAINS PIPE CONDITION ASSESSMENT STUDY

Corr-Tech Impressed Current Cathodic Protection
Evaluation and Pipe Wall Structural Reliability Assessment

Pure Technologies Sahara Probe - Acoustic and CCTV
Internal Pipe Leak Detection and Visual Inspection

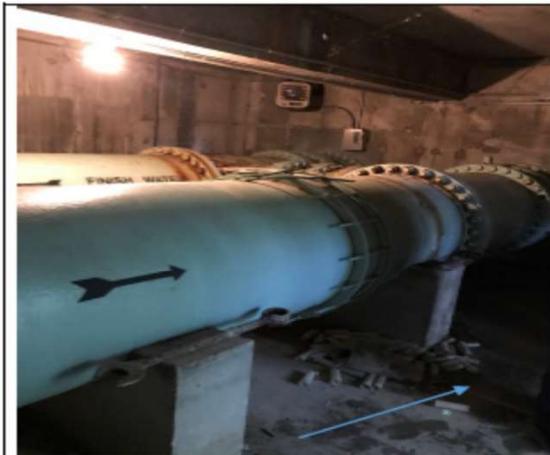
Huron Ave Vault, Insulator Kit on Floor at Flange

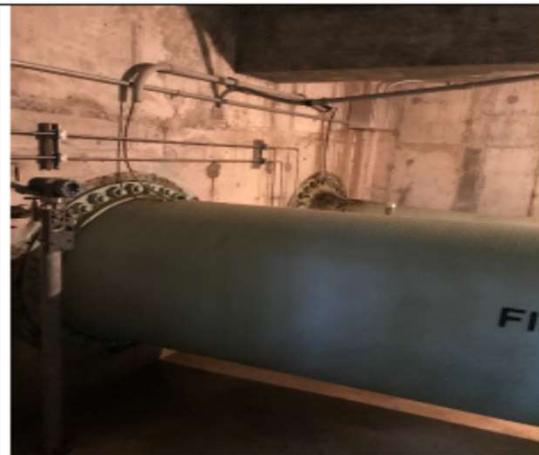
Huron Ave Vault, Electrical Continuity Bond

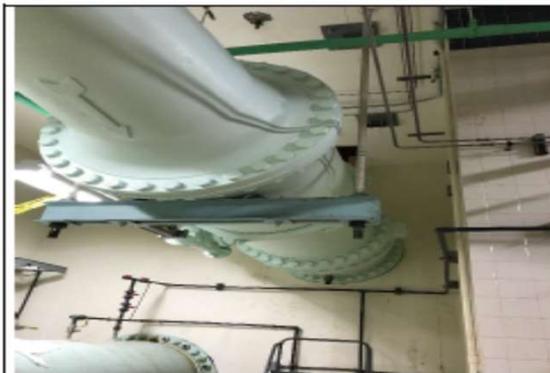
Pipe "Run A" at Water TP Basement where insulator is recommended to be installed

The existing cathodic protection system should be repaired or replaced to mitigate corrosion on external below grade surfaces.

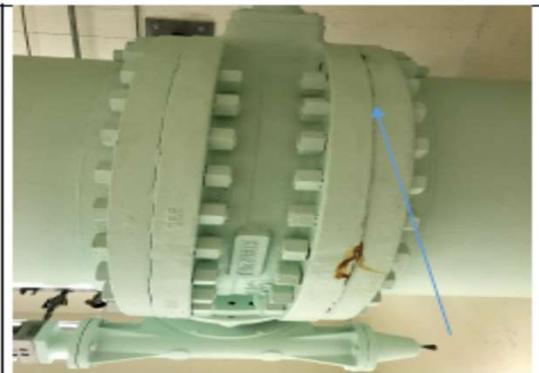
Pipe "Run A" at Water TP Basement where insulator is recommended to be installed

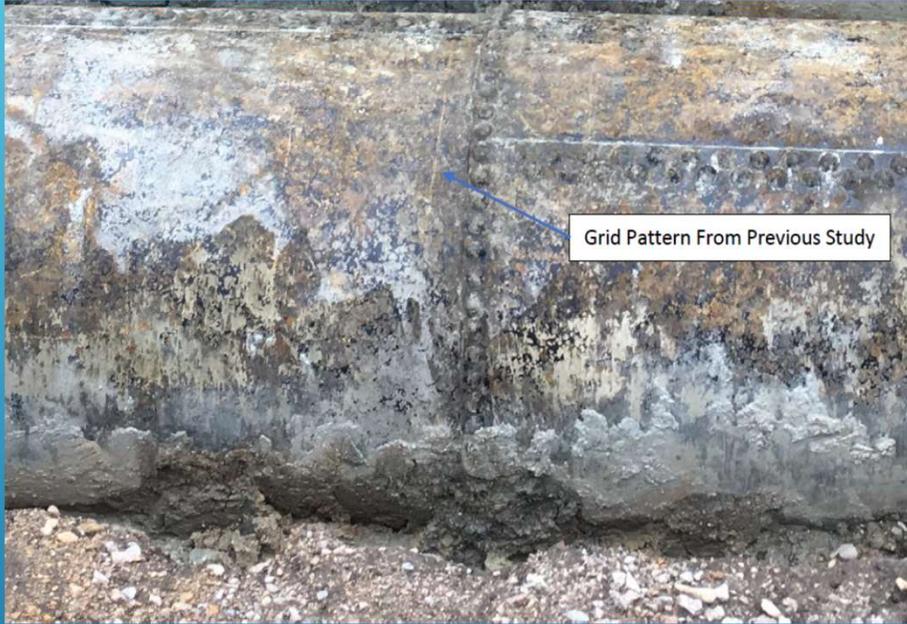
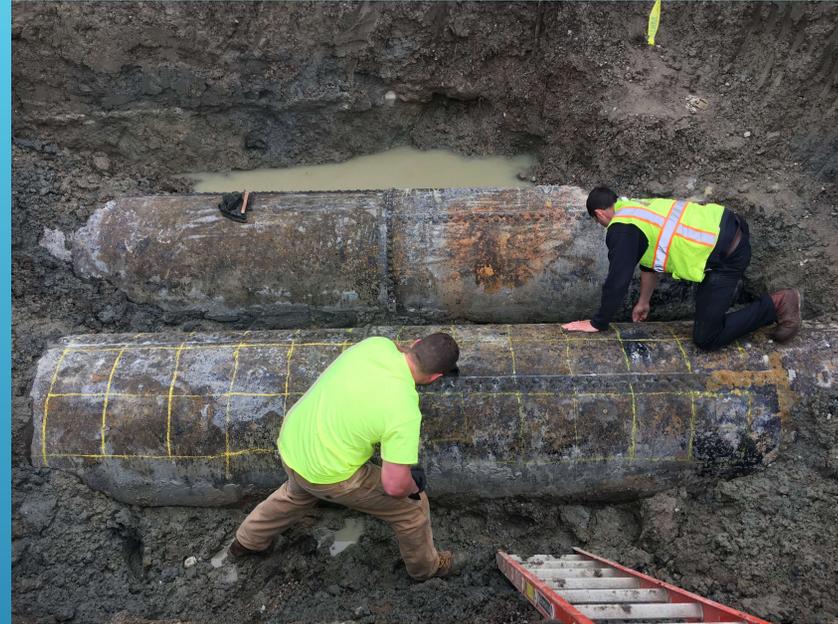
CORR-TECH SETTING UP GRID PATTERN FOR
ULTRASONIC PIPE WALL THICKNESS TESTING
NOTE – WE COULD STILL SEE THE GRID
FROM PREVIOUS 1999 STUDY!

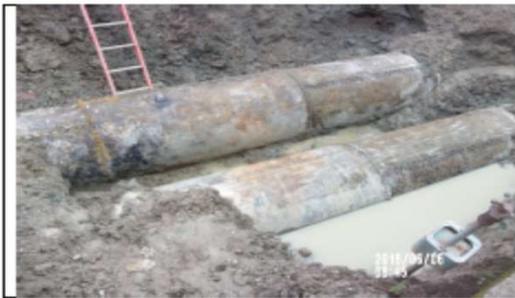
General View of Open Trench

Soil samples taken Glacken Field excavation were tested and determined to be moderately corrosive with a corrosivity index value of negative two (-2) and negative three (-3).

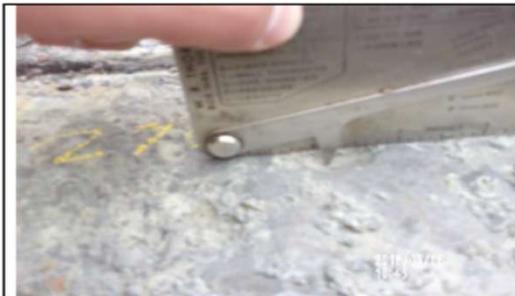
Pipe close-up, 270 mil gouge

Significant wall thickness presently remains at all pipe sections tested. Pitting ranges and thinning of wall thicknesses have not significantly increased since the inspection performed in 1999 at approximately the same locations. Based on the two excavations and direct assessments performed, structural lining or replacement of these main is not necessary at this time.

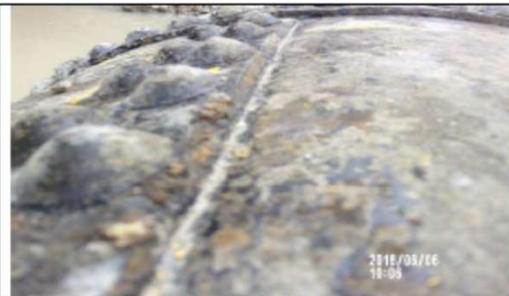
Pipe close-up of rivet seam
